**BEFORE THE HON'BLE NATIONAL GREEN TRIBUNAL,
SOUTHERN ZONE, CHENNAI**

O.A. No. 268 OF 2017 (SZ)

**PRESENTED BY JUSTICE A.V.RAMAKRISHNA PILLAI
(FORMER JUDGE, HIGH COURT OF KERALA)
CHAIRMAN, STATE LEVEL MONITORING COMMITTEE, KERALA
(FOR AND ON BEHALF OF THE AFORESAID COMMITTEE)
REGARDING THE ALLEGED ENCROACHMENT INTO THE
CHERUTHONY RIVER AND THE NEARBY FOREST AREA
IN IDUKKI DISTRICT**

PRESENTED ON : 26.09.2020

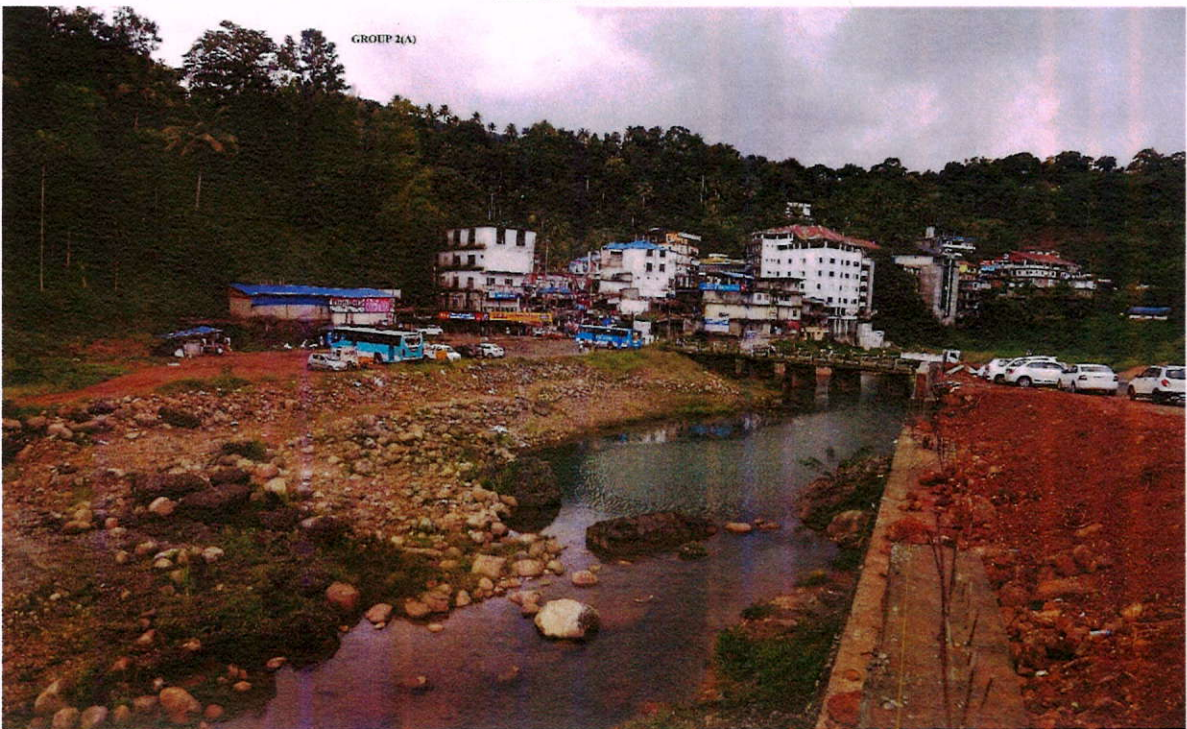
GROUP 2 (I)

7. The check dam made mention of in original application was seen practically destroyed due to the flood in 2018.
8. The pay and park area and the toilet made mention of in the original application are not existing now. However, a public toilet exist near the bus stand at present. There a soak pit attached to the septic tank was seen provided for disposal of black water.
9. A crusher unit by name CMJ granite is situated at a distance from the river. However, it is not functioning now.

View of Cheruthoni River (Upstream side)

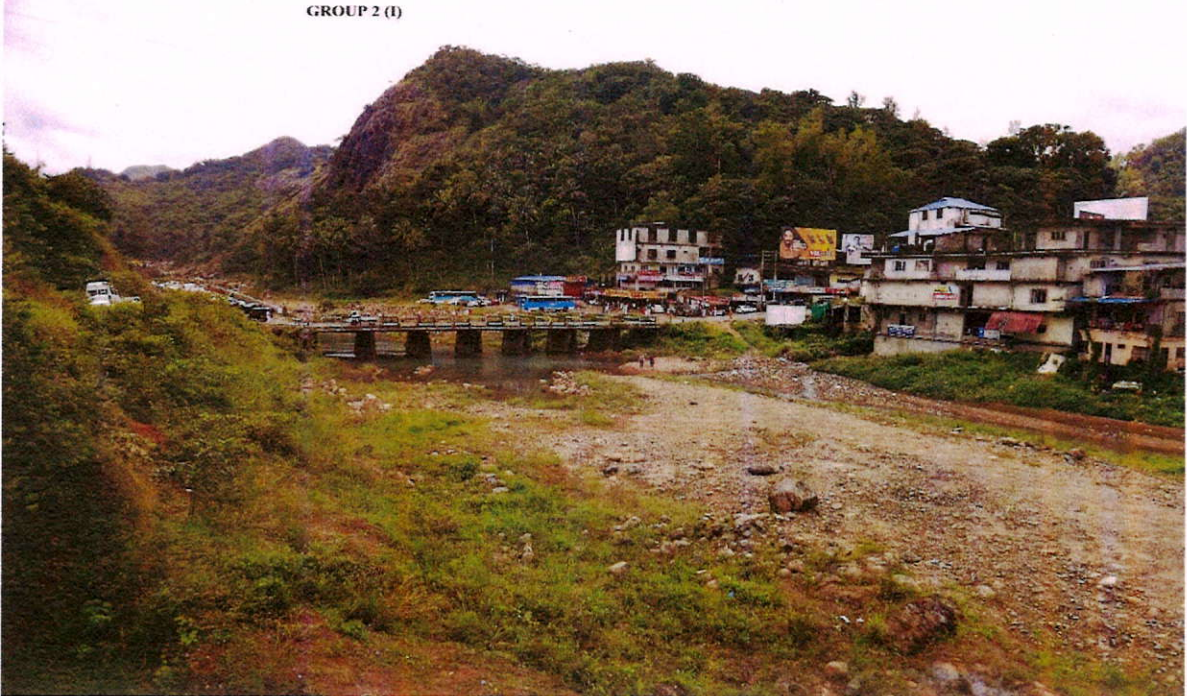
GROUP 2 (D)

View of Cheruthoni River(Downstream side)

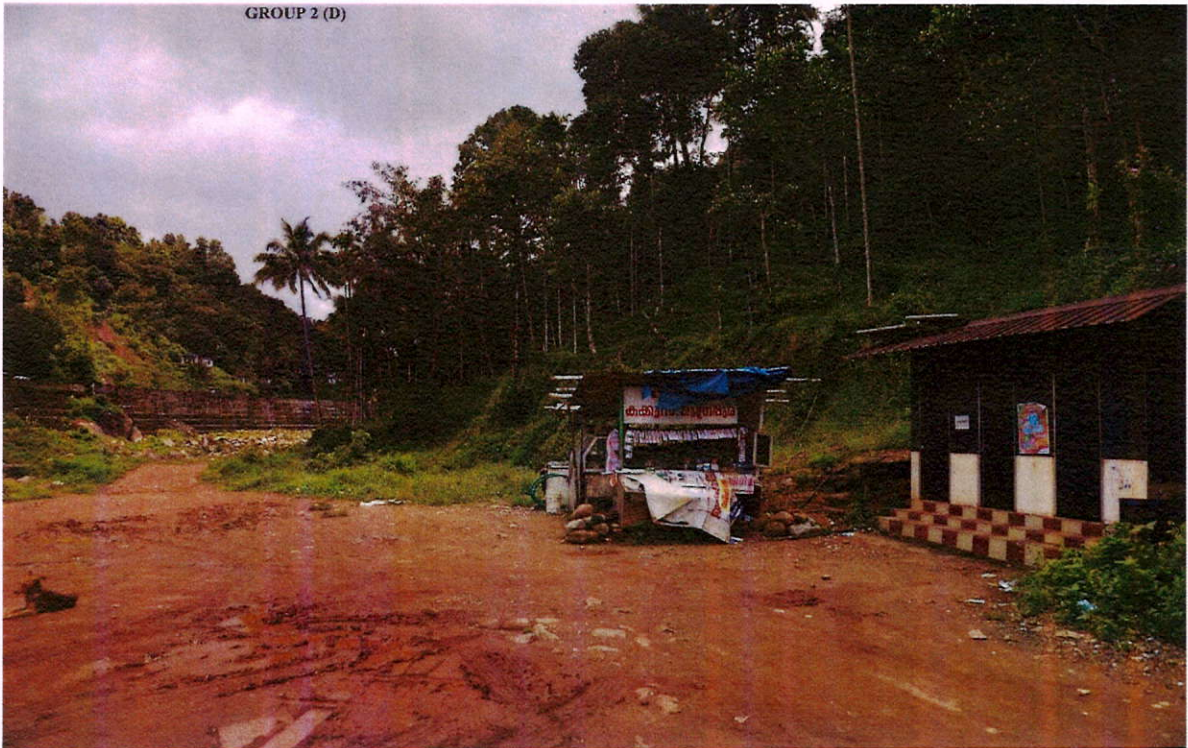
Public toilet near bus stand

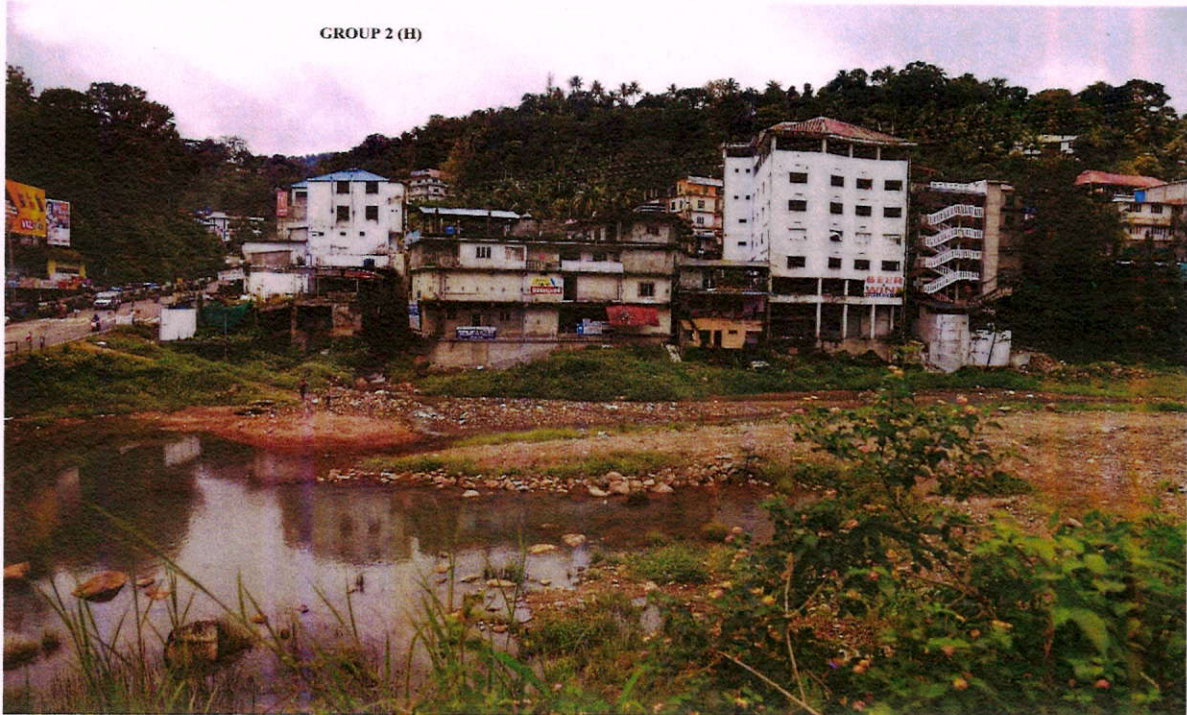
1. There are small restaurants, lodges, commercial establishments and residential apartments on one bank of the Cheruthony river. The other bank is almost a free land.
2. A non-perennial stream flows through Cheruthony town and it joins at Cheruthony river.
3. In all the commercial as well as residential establishments, septic tanks with soak pit system are seen provided. However, these are located on the bank of the river itself.
4. All most all restaurants have leach ate collecting pits. These are for collecting wash water.

Reportedly, inspection was conducted in all establishments to verify their system of waste water disposal. The details are given in **Annexure-A1** schedule appended. It was also reported that, due land constrains and due the presence of vegetation at the banks of the river, a detailed verification could not be conducted for ascertaining whether there is unauthorised discharge of waste water into the river.

Buildings situated on the bank of Cheruthoni river

river. The irrigation department is duty bound to see that the river is not encroached upon by riparian owners. The forest department is legally bound to protect the forest area from illegal encroachments and constructions. Unless there is earnest effort on the part of the authorities concerned, the very existence of our natural resources will be at peril.

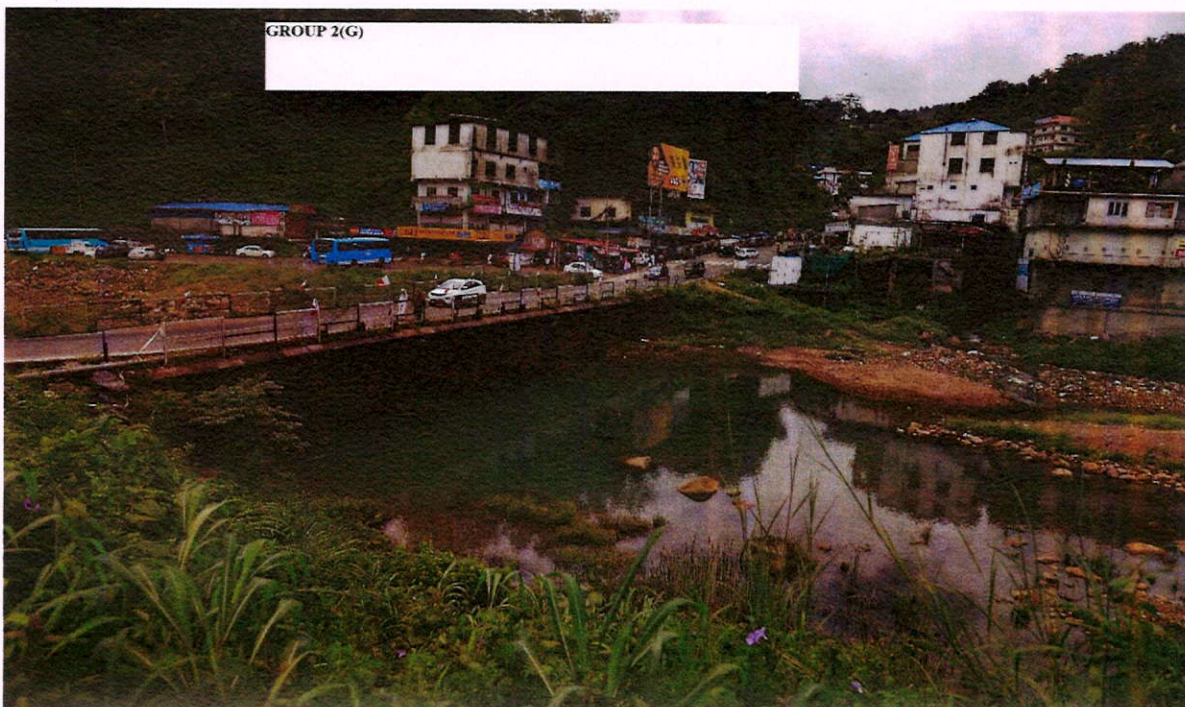
Cheruthoni Bridge

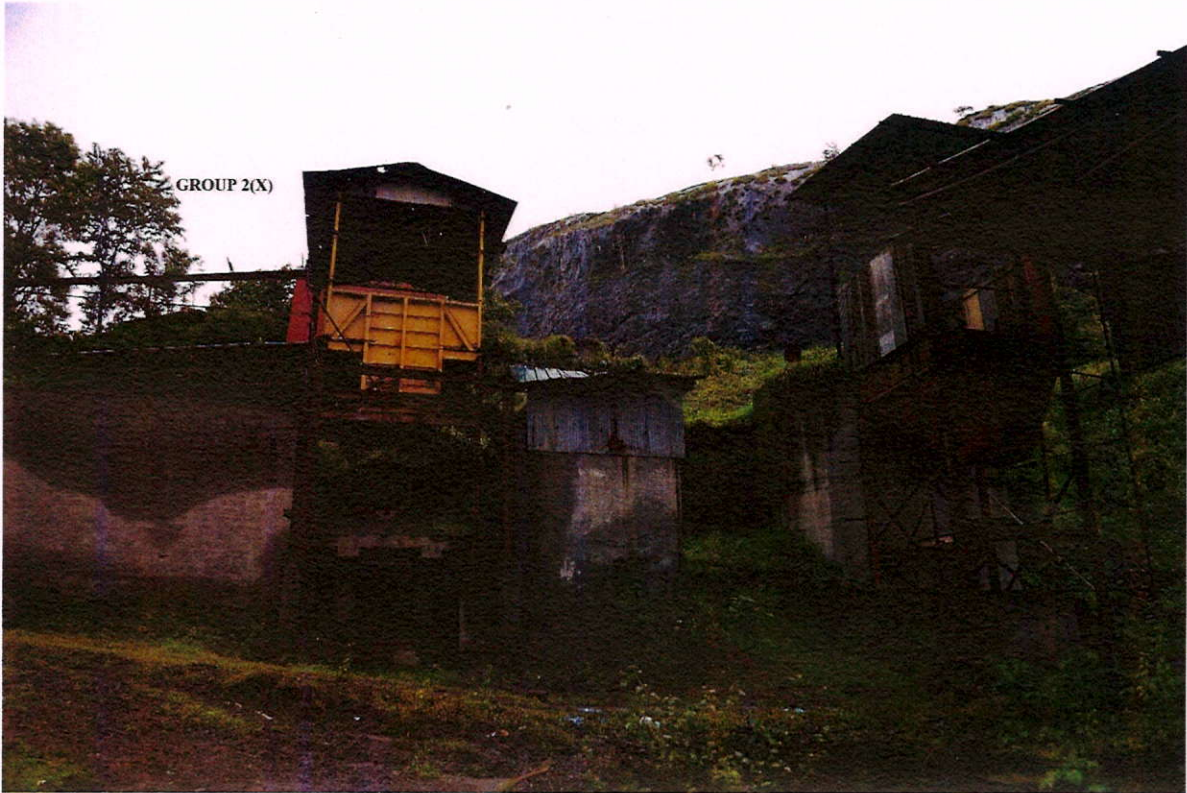
View of CMJ granites Crusher unit

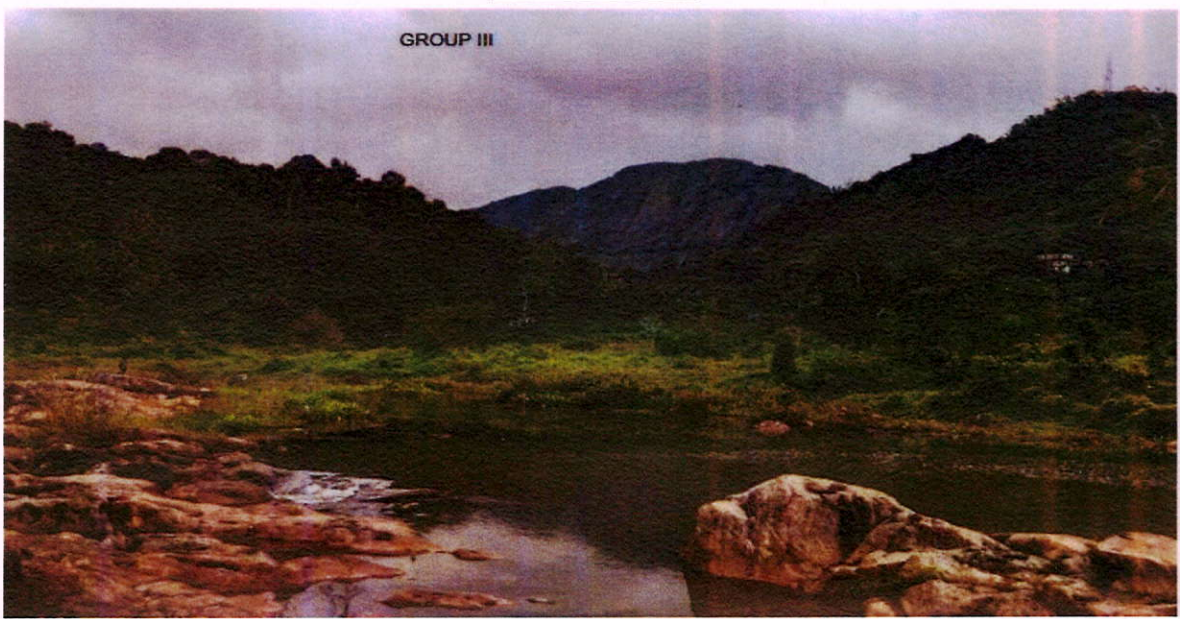
GROUP III

Periyar and cheruthoni River Joining point
