**State Level Monitoring Committee, Kerala**

**O.A. Nos.442/2013(SZ), 20/2017(SZ) and 276/2017(SZ)**

**PRESENTED BY JUSTICE A.V.RAMAKRISHNA PILLAI  
(FORMER JUDGE, HIGH COURT OF KERALA)  
CHAIRMAN, STATE LEVEL MONITORING COMMITTEE, KERALA  
(FOR AND ON BEHALF OF THE AFORESAID COMMITTEE)  
REGARDING THE FIRE INCIDENT OCCURED ON 02.03.2023 IN THE  
SOLID WASTE DUMPING YARD AT BRAHMAPURAM IN  
ERNAKULAM DISTRICT**

**PRESENTED ON : 13.03.2023**

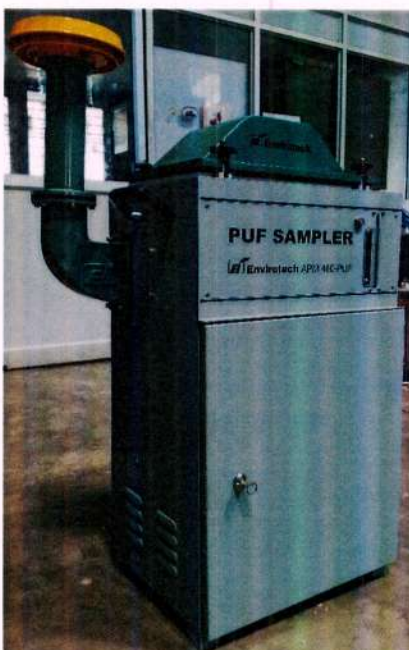
**Fig 1: Ambient air PUF sampler**

3. All glass PUF cartridges – Polyurethane foam media was used for adsorbing the vapour phase dioxins from the ambient air. To hold the PUF plug all glass made cartridge was used as metallic surfaces may react with dioxins.

4. Electromechanical time totalizer – the sampling duration was recorded in the instrument itself using automated timer which can be used to run the instrument for pre-set duration.

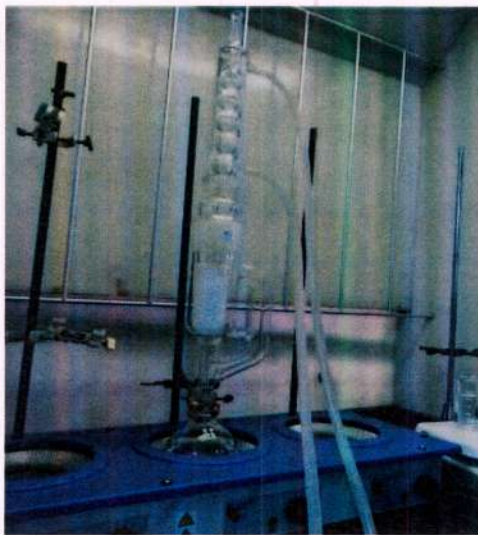
**Fig 2: Soxhlet Extraction System**

1. Solvent container – Extraction solvent can be taken in the solvent container and the soxhlet flask need to be connected to the ground joint solvent container.
2. Soxhlet flask – The sample is placed in the soxhlet flask and the hot solvent will extract the organics in the sample by the siphoning effect.
3. Condenser – Cold water will be circulated continuously in the condenser to cool and condense the hot solvent vapour generated during the extraction process.

Upon heating the solvent in the container get vaporised and move through the Soxhlet flask and reach the condenser on the top. The condensed hot solvent will drip back to the Soxhlet chamber where the sample is placed. The hot solvent will dissolve off the organic content in the sample matrix and on reaching the flask volume, it will flush out to the solvent container by siphoning action. The process is repeated for several cycles so as to ensure quantitative extraction of compounds of interest.

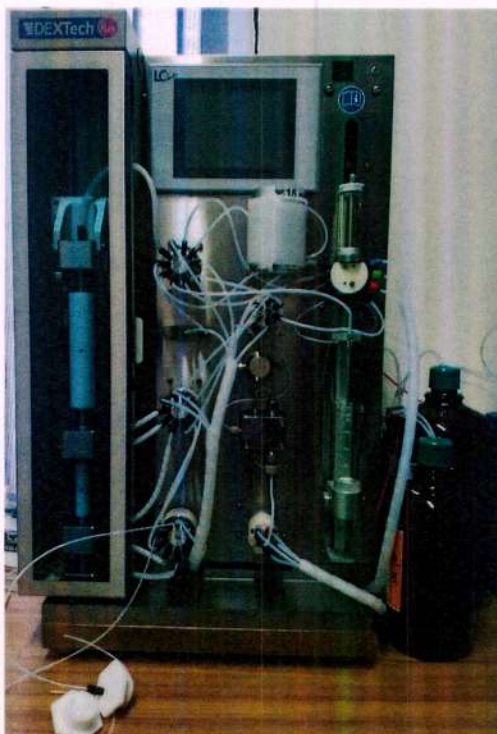
**Fig 3: Automated Dioxin clean up system**

The extracted sample obtained after Soxhlet process contain interfering compounds and co-extractants such as humic acids, polymeric ingredients, plasticizers, fatty materials and other organic impurities along with the compounds of interest. The removal and separation of these interfering matrices is essential for the quantification of dioxins. Sample cleanup is the rate determining step in the dioxin analysis as it involves multiple column cleanup procedures to remove the interfering matrices and to separate dioxins and dioxin like compounds into two fractions for quantitation. The samples will be passed through a multilayer silica column (column consists of  $\text{H}_2\text{SO}_4$  impregnated silica gel, KOH silica gel and neutral silica gel) at first to remove any organic interferents or similar co-extractants. Then the eluent will be passed through alumina and carbon columns in series to remove similar mass interferences and to separate into dioxins and dioxin like compound fraction.

DEXTech Pure (A fully automated sample cleanup system supplied by LCTech, Germany) was used for the sample cleanup of both air and ash samples. The total run time of the instrument is 65 minutes.

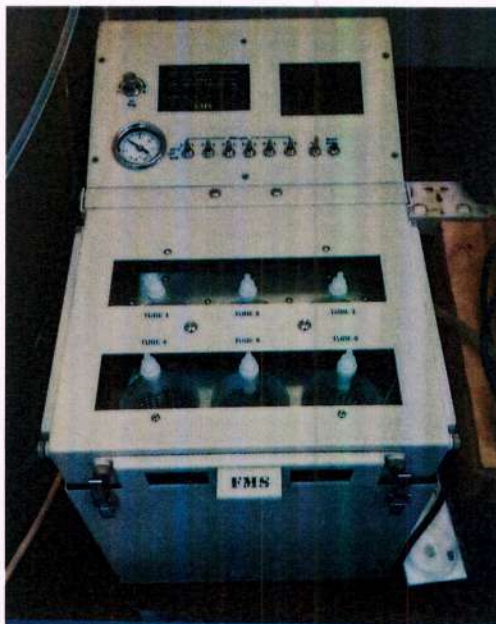
**Fig 4: Nitrogen Evaporator**

The fractions obtained after cleanup requires volume reduction to as low as 200 microliters as the analytes of interest are present in low picogram levels. Nitrogen evaporator/concentrator supplied by M/s. FMS Inc., USA (fig 4) was used for concentrating the fractions to near dryness. The fractions were concentrated by simultaneous nitrogen purging and heating inside a contained atmosphere. Custom made concentrating tubes were used to perform the concentration/evaporation of the solvent to reduce it to 200 $\mu$ l. Continuous vacuum will be applied inside the container for expelling the evaporated solvent from the system. Purge flow and temperature can be controlled throughout the process. The instrument minimizes the losses due to the volatility of the compounds and nullifies the chances of cross contamination. Ultrahigh purity (UHP) nitrogen is used for the purging process.

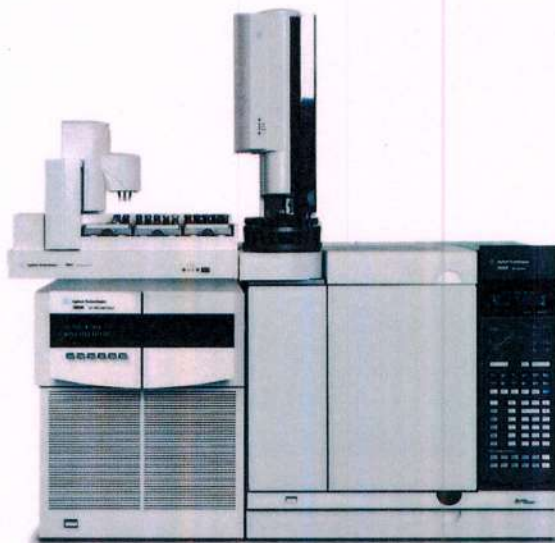
**Fig 5: Gas Chromatography – Triple Quadrupole Mass Spectrometer**

A triple quadrupole mass spectrometer (GC-MS/MS) is used for the quantification of dioxins and furans. Agilent Technologies Make 7890 Series gas chromatograph coupled to 7000C Quadrupole MS/MS was used for the study (Fig 5).

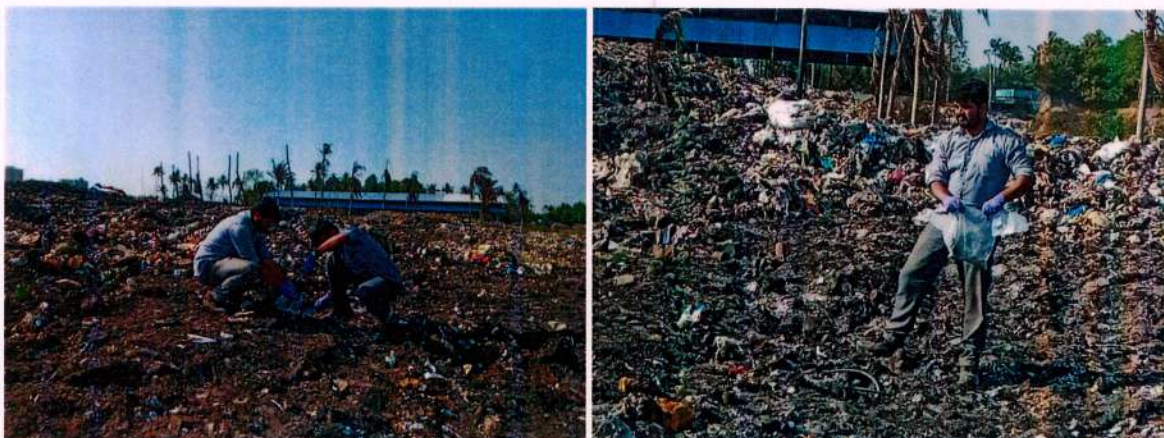
**Fig 8a & 8b: Collection of Ash and residue from the site**

Apart from air samples, the residual ash from various points in the waste pile was also collected for analysis (Fig. 8a & 8b). Many areas of the waste heaps were not accessible due to safety considerations at the site. Residues were collected from 8 points and were reduced to 4 composite samples (appr. 100 g each) by conning and quartering considering the area of collection.

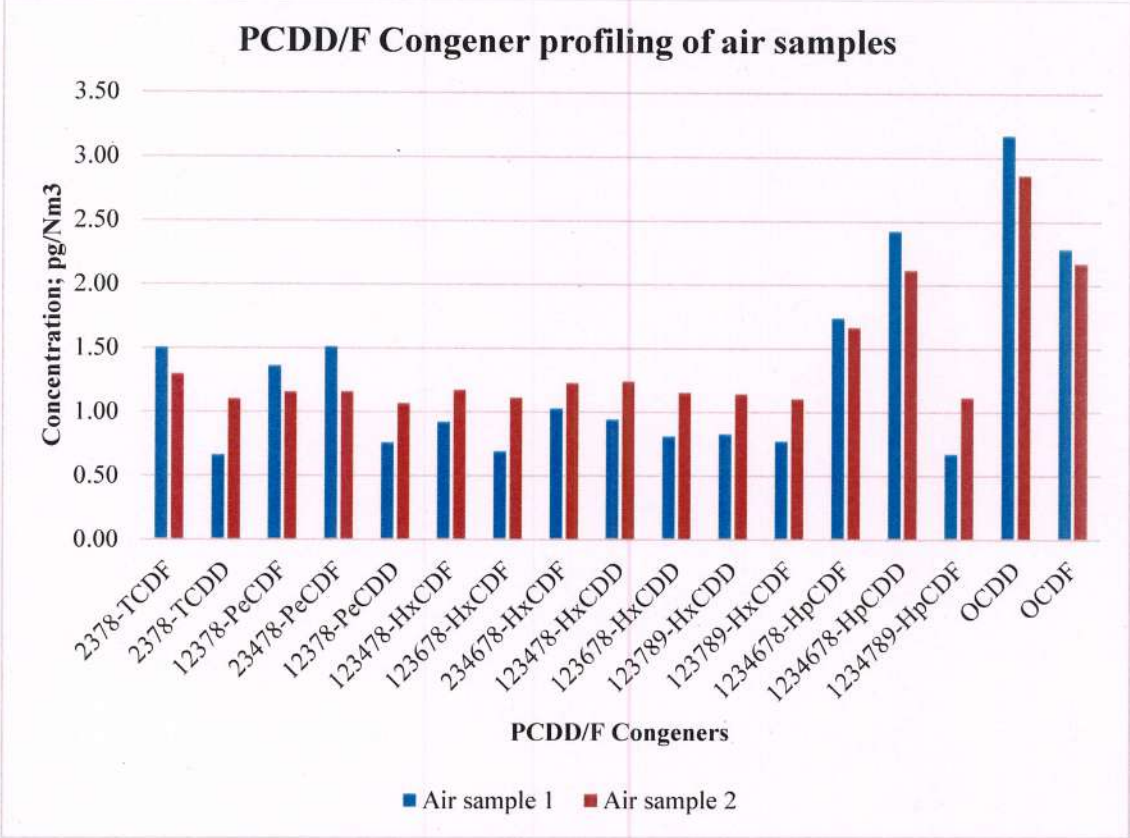
Fig 10: PCDD/F congener profiling in ambient air samples

A comparative study on the observed levels of each dioxin congener on the basis of its contribution to total toxicity equivalence (TEQ) was also conducted. Fig 10, 11 and 12 shows the congener distribution profile in ambient air, residual ash and congener specific distribution to TEQ in air and ash samples. All the samples showed predominance of lower chlorinated dioxins and furans (tetra and penta) in terms of toxicity equivalence. TCDD (the known human carcinogen) the most toxic congener with WHO TEF value 1 was detected in all the samples. Hepta and octa chlorinated species were found to be particularly higher in all the samples. The mechanistic studies regarding the formation of dioxins suggest that the during combustion processes higher chlorinated forms will be the major product and with time de-chlorination will lead to formation of more stable lower chlorinated ones. The furan to dioxin ratio was found to be 1:0.8 in air samples and 0.8:1 in ash samples. More details on the dioxin formation tendencies during such an open fire breakout need deeper investigation on various critical parameters influencing the predominance of particular congeners such as the waste composition, temperature, oxygen levels etc. In fact it is extremely difficult to conduct such

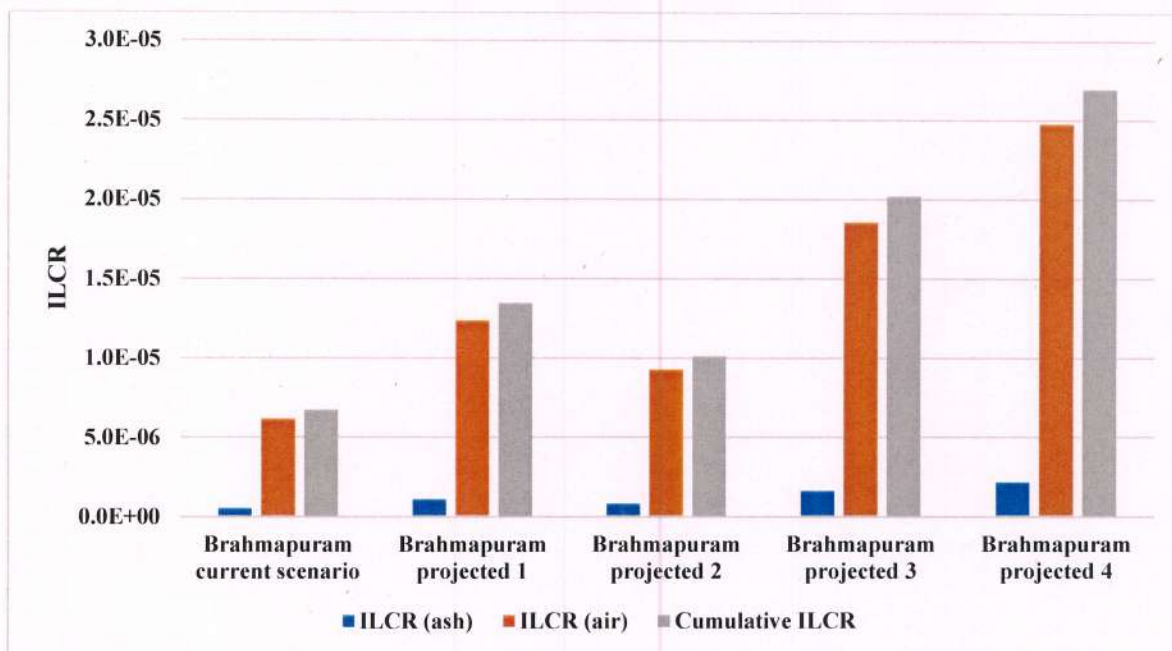
**Fig 14; Graph showing the carcinogenic risk factors at the site currently and the four projected scenarios**

The results are as shown in the fig 14. It can be observed that increase in exposure factor or duration can significantly affect the ILCR of the exposed community. In the first projection where duration was kept the same and frequency was doubled an ILCR value in the range of  $1 \times 10^{-5}$  was observed. This value indicates that 1 additional person per one lakh people of the exposed community can develop carcinogenic effects in lifetime. When both exposure frequency as well as duration is doubled ILCR crossed  $2.5 \times 10^{-5}$  closing to the unacceptable level of  $1 \times 10^{-4}$ . ILCR of  $1 \times 10^{-4}$  indicates that 1 additional person out of 10000 people of the exposed community can develop carcinogenic effects over lifetime and is considered unacceptable by USEPA. Therefore, restoration of the site is highly recommended as accidental fires are inevitable in MSW dumpyards due to its unscientific structure. Even though the factors observed presently at the site is below  $1 \times 10^{-4}$ , considering the study limitations such as the absence of ingestion exposure data (through animal origin food consumption in the region), exact number of incident days, dioxins depositional flux at the site and the rate of other dispersal mechanisms the actual cumulative cancer risk could be higher than those calculated in the present study.
