REPORT

PRESENTED BY JUSTICE A.V.RAMAKRISHNA PILLAI
(FORMER JUDGE, HIGH COURT OF KERALA)
CHAIRMAN, STATE LEVEL MONITORING COMMITTEE, KERALA
(FOR AND ON BEHALF OF THE AFORESAID COMMITTEE)
REGARDING THE UNAUTHORISED DUMPING OF
NON-DEGRADABLE SOLID WASTE ALONG THE BANKS OF KOCHI
BACK WATERS ON THE SOUTHERN SIDE OF THOPPUMPADY –
KUNDANNOOR ROAD (BETWEEN ALEXANDER PARAMBITHARA
BRIDE AND KANNANGATT BRIDGE) IN WILLINGDON ISLAND, IN
ERNAKULAM DISTRICT

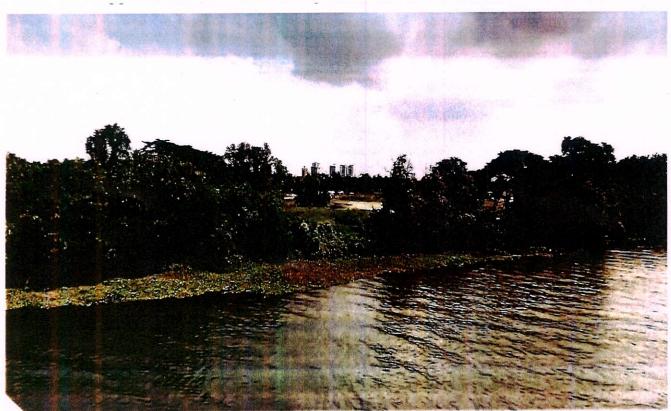
There was visible violation of solid waste disposal in that area which is ecologically fragile, as the dumping side is very close to back waters where mangrove forests are seen along the banks (Kindly see **Annexure-IV(a)** photograph). There is every chance of leach ate flow from waste heaps to the backwaters. **Annexure-IV(b)** to **IV(d)** are views of the dumping area from the road.

Photo 1 - A view of the dump site very near to Kochi kayal where thick mangrove Forest are seen along the banks.

As it is likely to cover up the illegality by spilling soil over the waste to make it appear that the waste materials are removed, immediate intervention of this Tribunal is required in this matter.

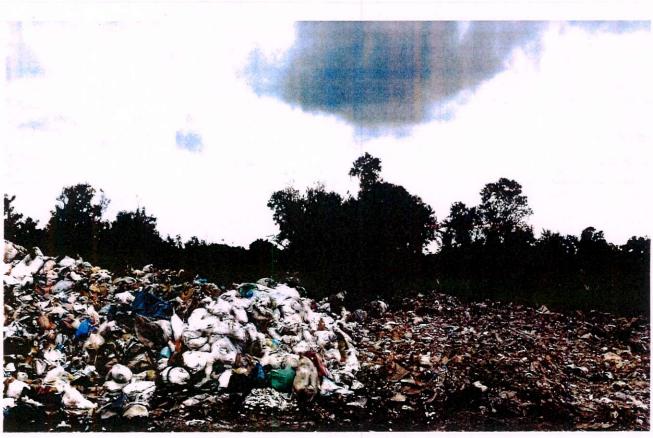
AUNEXURE-IV (6)

It was shocking to note that solid and hazardous non-degradable waste materials were seen dumped over an area covering a length of about 200 Meters on the bank of the backwaters, south to the public road between Alexander Parambithara Bridge (crossing over Kollam – Kottappuram National Water Way) and Kannangatt Bridge. The entire road side was seen dumped with non-degradable solid waste. Prima facie it appeared that the waste dumping in that area has commenced months back. At the entrance of the area, a trench was seen dug to prevent the entry of heavy vehicles carrying waste materials to that area. The Chief Environmental Engineer stated that it was at the intervention of the District Collector on receiving the recent complaint.

Photo 2 - Solid waste including plastic are seen dumped along the area

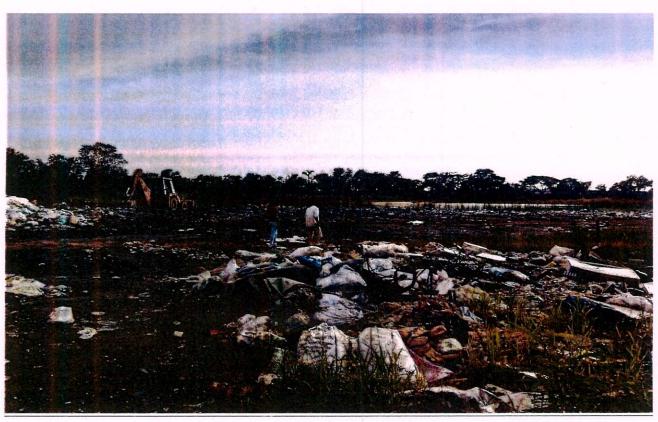
ANNEXURE-IV (d)

Photo 4 - A view of a water body along the rear side of the dumping area.
